4. Context and Preconditions for the Blackout: The Northeastern Power Grid Before the Blackout Began

This chapter reviews the state of the northeast portion of the Eastern Interconnection during the days and hours before 16:00 EDT on August 14, 2003, to determine whether grid conditions before the blackout were in some way unusual and might have contributed to the initiation of the blackout. Task Force investigators found that at 15:05 Eastern Daylight Time, immediately before the tripping (automatic shutdown) of FirstEnergy’s (FE) Harding-Chamberlin 345-kV transmission line, the system was electrically secure and was able to withstand the occurrence of any one of more than 800 contingencies, including the loss of the Harding-Chamberlin line. At that time the system was electrically within prescribed limits and in compliance with NERC’s operating policies.

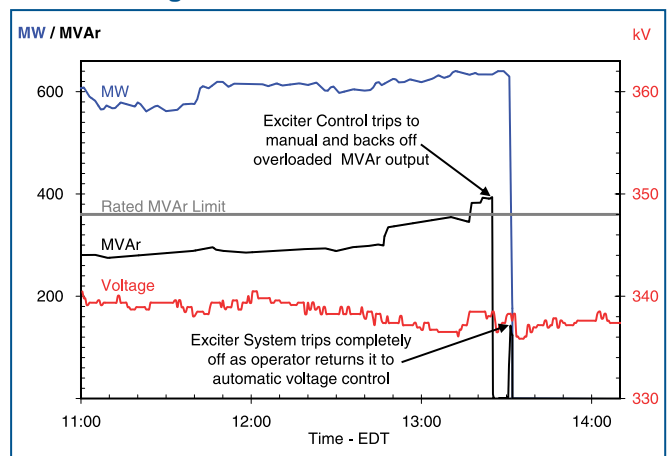
Figure 4.3. MW and MVar Output from Eastlake Unit 5 on August 14

- ◆ Eastlake Unit 5 is a 597 MW (net) generating unit located west of Cleveland on Lake Erie. It is a major source of reactive power support for the Cleveland area. It tripped at 13:31 EDT. The cause of the trip was that as the Eastlake 5 operator sought to increase the unit's reactive power output (Figure 4.3), the unit's protection system detected that VAR output exceeded the unit's VAR capability and tripped the unit off-line. The loss of the Eastlake 5 unit did not put the grid into an unreliable state—i.e., it was still able to withstand safely another contingency. However, the loss of the unit required FE to import additional power to make up for the loss of the unit's output (612 MW), made voltage management in northern Ohio more challenging, and gave FE operators less flexibility in operating their system (see details on pages 45-46 and 49-50).
