4. Context and Preconditions for the Blackout: The Northeastern Power Grid Before the Blackout Began

This chapter reviews the state of the northeast portion of the Eastern Interconnection during the days and hours before 16:00 EDT on August 14, 2003, to determine whether grid conditions before the blackout were in some way unusual and might have contributed to the initiation of the blackout. Task Force investigators found that at 15:05 Eastern Daylight Time, immediately before the tripping (automatic shutdown) of FirstEnergy’s (FE) Harding-Chamberlin 345-kV transmission line, the system was electrically secure and was able to withstand the occurrence of any one of more than 800 contingencies, including the loss of the Harding-Chamberlin line. At that time the system was electrically within prescribed limits and in compliance with NERC’s operating policies.

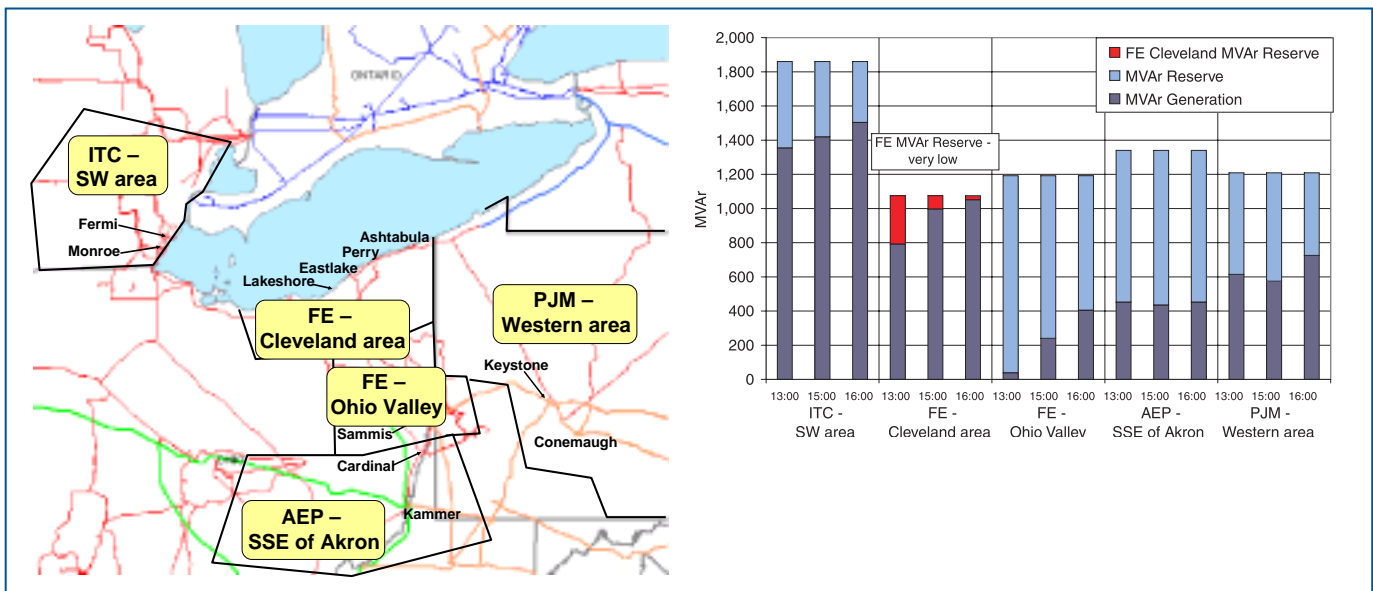
Figure 4.8. Reactive Reserves Around Ohio on August 14, 2003, for Representative Generators in the Area

Using actual data provided by FE, ITC, AEP and PJM, Figure 4.8 shows the availability of reactive reserves (the difference between reactive power generated and the maximum reactive capability) within the Cleveland-Akron area and four regions surrounding it, from ITC to PJM. On the afternoon of August 14, the graph shows that reactive power generation was heavily taxed in the Cleveland-Akron area but that extensive MVAR reserves were available in the neighboring areas. As the afternoon progressed, reactive reserves diminished for all five regions as load grew. But reactive reserves were fully depleted within the Cleveland-Akron area by 16:00 EDT without drawing down the reserves in neighboring areas, which remained at scheduled voltages. The region as a whole had sufficient reactive reserves, but because reactive power cannot be transported far but must be supplied from

local sources, these healthy reserves nearby could not support the Cleveland-Akron area's reactive power deficiency and growing voltage problems. Even FE's own generation in the Ohio Valley had reactive reserves that could not support the sagging voltages inside the Cleveland-Akron area.

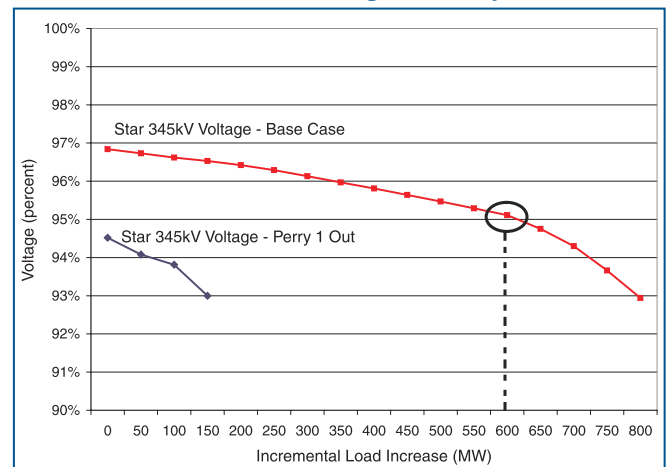
Figure 4.10. Impact of Perry Unit Outage on Cleveland-Akron Area Voltage Stability

load level of 13,229 MW for the control area (in August 2002). Therefore the investigation team looked at what might have happened in the Cleveland-Akron area had loads neared the historic peak—approximately 625 MW higher than the 6,715 MW peak load in the Cleveland-Akron area in 2003. Figure 4.10 uses P-V analysis to show the impact of increased load levels on voltages at the Star bus with and without the Perry unit before the loss of the Harding-Chamberlin line at 15:05 EDT. The top line shows that with the Perry plant available, local load could have increased by 625 MW and voltage at Star would have remained above 95%. But the bottom line, simulating the loss of Perry, indicates that load could only have increased by about 150 MW before voltage at Star would have become unsolvable, indicating no voltage stability margin and depending on load dynamics, possible voltage collapse.

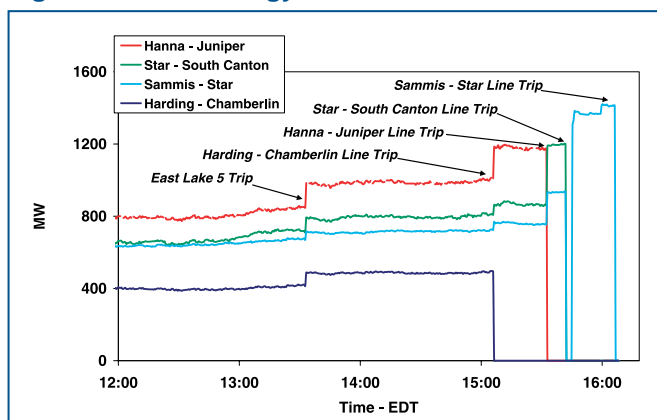
Figure 5.5. FirstEnergy 345-kV Line Flows

From 15:05:41 EDT to 15:41:35 EDT, three 345-kV lines failed with power flows at or below each transmission line's emergency rating. These line trips were not random. Rather, each was the result of a contact between a line and a tree that had grown so tall that, over a period of years, it encroached into the required clearance height for the line. As each line failed, its outage increased the loading on the remaining lines (Figure 5.5). As each of the transmission lines failed, and power flows shifted to other transmission paths, voltages on the rest of FE's system degraded further (Figure 5.6).

A short-circuit occurred on the Harding-Chamberlin 345-kV line due to a contact between the line conductor and a tree. This line failed with power flow at only 44% of its normal and emergency line rating. Incremental line current and temperature increases, escalated by the loss of Harding-Chamberlin, caused more sag on the Hanna-Juniper line, which contacted a tree and failed with power flow at 88% of its normal and emergency line rating. Star-South Canton

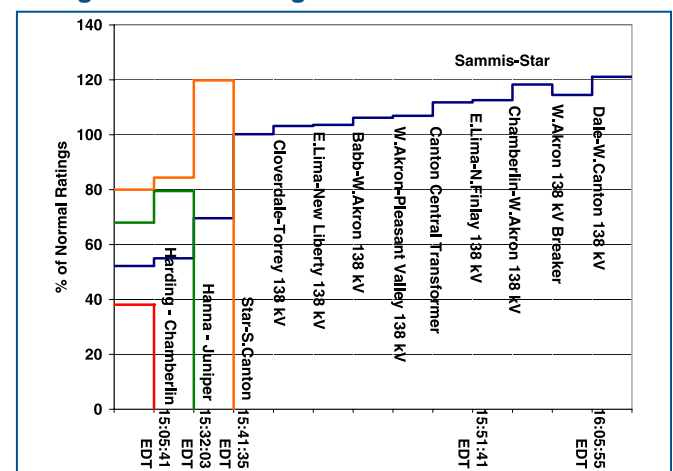
Figure 5.12. Cumulative Effects of Sequential Outages on Remaining 345-kV Lines

the loss of the Harding-Chamberlin 345-kV line. Figure 5.12 shows the line loadings estimated by investigation team modeling as the 345-kV lines in northeast Ohio began to trip. Showing line loadings on the 345-kV lines as a percent of normal rating, it tracks how the loading on each line increased as each subsequent 345-kV and 138-kV line tripped out of service between 15:05 EDT (Harding-Chamberlin, the first line above to stair-step down) and 16:06 EDT (Dale-West Canton). As the graph shows, none of the 345- or 138-kV lines exceeded their normal ratings until after the combined trips of Harding-Chamberlin and Hanna-Juniper. But immediately after the second line was lost, Star-South Canton’s loading jumped from an estimated 82% of normal to 120% of normal (which was still below its emergency rating) and remained at the 120% level for 10 minutes before tripping out. To the right, the graph shows the effects of the 138-kV line failures (discussed in the next phase) upon the two remaining 345-kV lines—i.e., Sammis-Star’s loading increased steadily above 100% with each succeeding 138-kV line lost.

- ◆ The Star-Juniper 345-kV line, whose loadings would exceed emergency limits if the Hanna-Juniper 345-kV line were lost; and

- ◆ The Hanna-Juniper and Harding-Juniper 345-kV lines, whose loadings would exceed emergency limits if the Perry generation unit (1,255 MW) were lost.

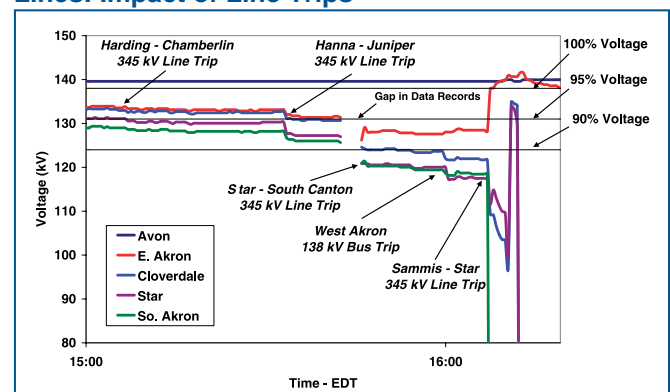
Figure 5.14. Voltages on FirstEnergy's 138-kV Lines: Impact of Line Trips

Figure 5.14 shows how actual voltages declined at key 138-kV buses as the 345- and 138-kV lines were lost. As these lines failed, the voltage drops caused a number of large industrial customers with voltage-sensitive equipment to go off-line automatically to protect their operations. As the 138-kV lines opened, they blacked out customers in Akron and the areas west and south of the city, ultimately dropping about 600 MW of load.

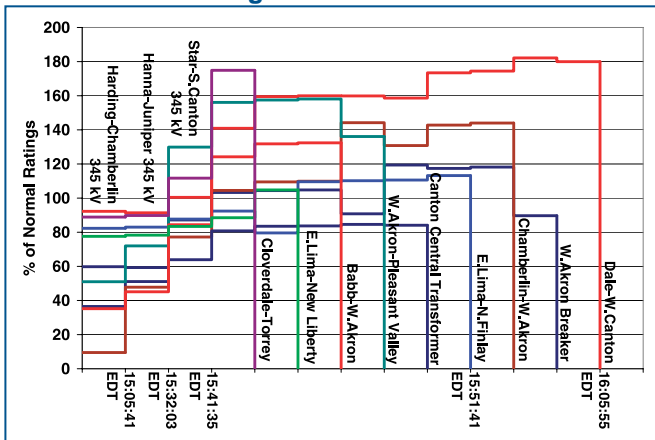
Figure 5.15. Simulated Effect of Prior Outages on 138-kV Line Loadings

Figure 5.15, derived from investigation team modeling, shows how the power flows shifted across FE's 345- and key 138-kV northeast Ohio lines as the line failures progressed. All lines were loaded within normal limits after the Harding-Chamberlin lock-out, but after the Hanna-Juniper trip at 15:32 EDT, the Star-South Canton 345-kV line and three 138-kV lines jumped above normal loadings. After Star-South Canton locked out at 15:41 EDT within its emergency rating, five 138-kV and the Sammis-Star 345-kV lines were overloaded. From that point, as the graph shows, each subsequent line loss increased loadings on other lines, some loading to well over 150% of normal ratings before they failed. The Sammis-Star 345-kV line stayed in service until it tripped at 16:05:57 EDT.

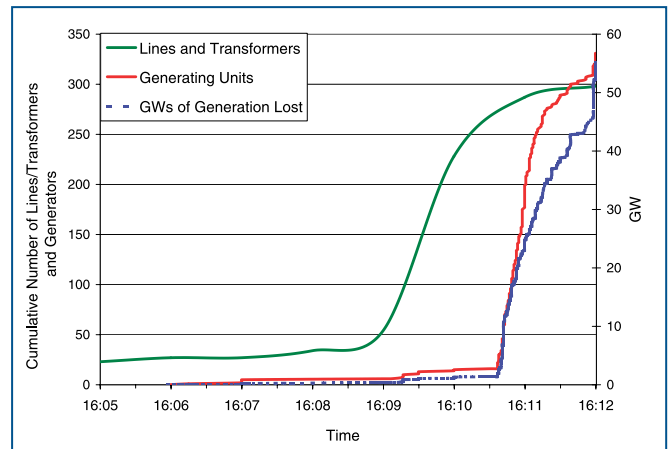
Figure 6.1. Rate of Line and Generator Trips During the Cascade

The events in the cascade started relatively slowly. Figure 6.1 illustrates how the number of lines and generation lost stayed relatively low during the Ohio phase of the blackout, but then picked up speed after 16:08:59 EDT. The cascade was complete only three minutes later.

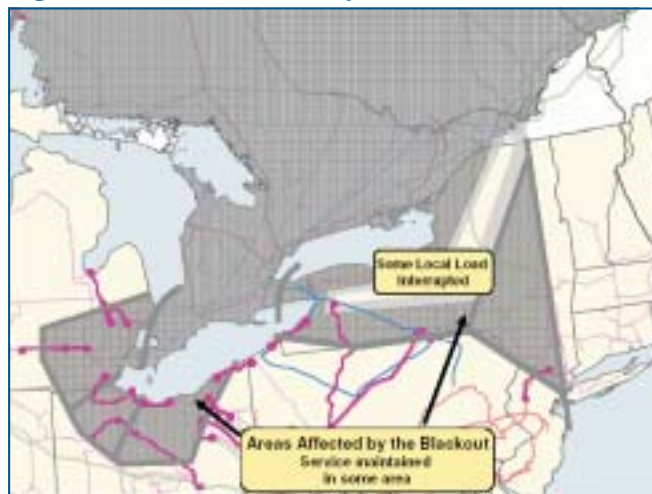
Figure 6.2. Area Affected by the Blackout

Although much of the disturbance area was fully blacked out in this process, some islands were able to reach equilibrium without total loss of service. For example, the island consisting of most of New England and the Maritime Provinces stabilized and generation and load returned to balance. Another island consisted of load in western New York and a small portion of Ontario, supported by some New York generation, the large Beck and Saunders plants in Ontario, and the 765-kV interconnection to Québec. This island survived but some other areas with large load centers within the island collapsed into a blackout condition (Figure 6.2).

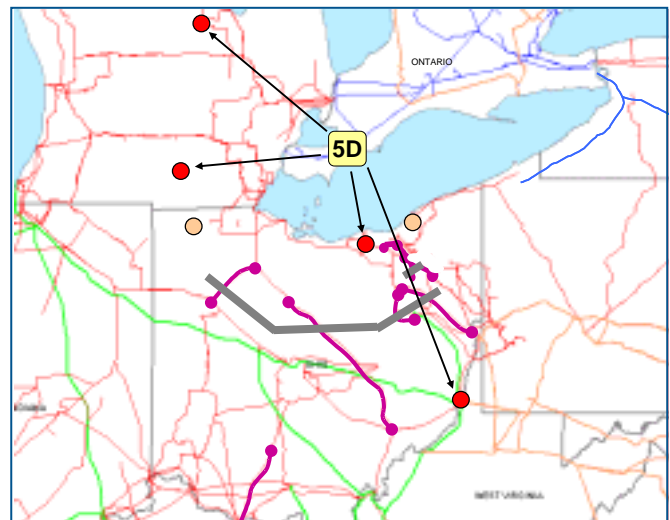
Figure 6.10. Michigan and Ohio Power Plants Trip

The Burger units tripped after the 138-kV lines into the Burger 138-kV substation (Ohio) tripped from the low voltages in the Cleveland area (Figure 6.10). The MCV plant is in central Michigan. Kinder Morgan is in south-central Michigan. The Kinder-Morgan units tripped due to a transformer fault and one due to over-excitation.

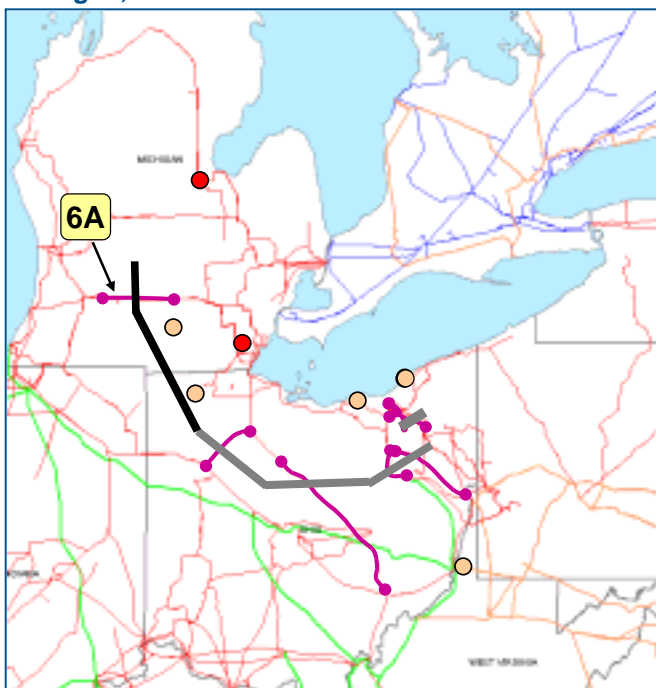
Figure 6.11. Transmission and Generation Trips in Michigan, 16:10:36 to 16:10:37 EDT

under-voltage on the system. Michigan lines west of Detroit then began to trip, as shown in Figure 6.11.

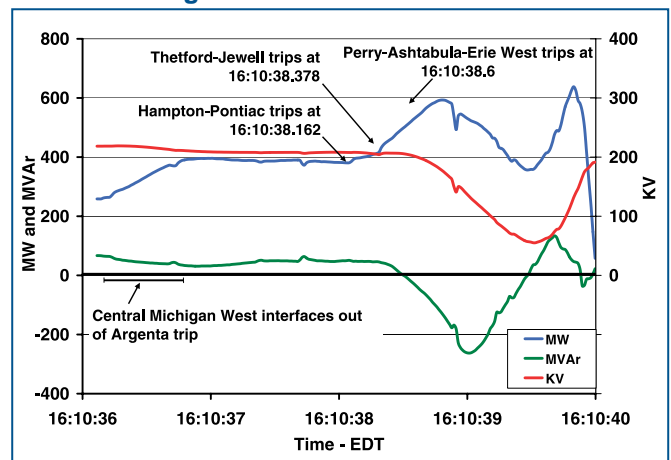
Figure 6.12. Flows on Keith-Waterman 230-kV Ontario-Michigan Tie Line

The Power System Disturbance Recorders at Keith and Lambton, Ontario, captured these events in the flows across the Ontario-Michigan interface, as shown in Figure 6.12 and Figure 6.16. It shows clearly that the west to east Michigan separation (the Thetford-Jewell trip) was the start and Erie West-Ashtabula-Perry was the trigger for the 3,700 MW surge from Ontario into Michigan. When Thetford-Jewell tripped, power that had been flowing into Michigan and Ohio from western Michigan, western Ohio and Indiana was cut off. The nearby Ontario recorders saw a pronounced impact as flows into Detroit readjusted to draw power from the northeast instead. To the south,

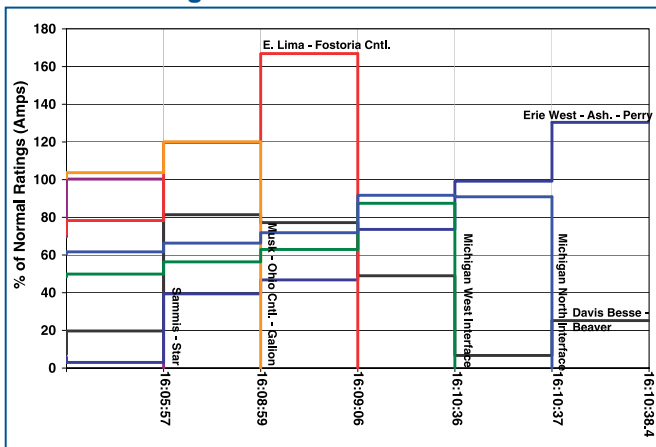
Figure 6.13. Simulated 345-kV Line Loadings from 16:05:57 through 16:10:38.4 EDT

Figures 6.13 and 6.14 show the results of investigation team modeling of the line loadings on the Ohio, Michigan, and other regional interfaces for the period between 16:05:57 until the Thetford-Jewell trip, to understand how power flows shifted during this period. The team simulated evolving system conditions on August 14, 2003, based on the 16:05:50 power flow case developed by the MAAC-ECAR-NPCC Operations Studies Working Group. Each horizontal line in the graph indicates a single or set of 345-kV lines and its loading as a function of normal ratings over time as first one, then another, set of circuits tripped out of service. In general, each subsequent line trip causes the remaining line loadings to rise; where a line drops (as Erie West-Ashtabula-Perry in Figure 6.13 after the Hanna-Juniper trip), that indicates that line loading lightened, most likely due to customers dropped from service. Note that Muskingum and East Lima-Fostoria Central were overloaded before they tripped, but the Michigan west and north interfaces were not overloaded before they tripped. Erie West-Ashtabula-Perry was loaded to 130% after the Hampton-Pontiac and Thetford-Jewell trips.

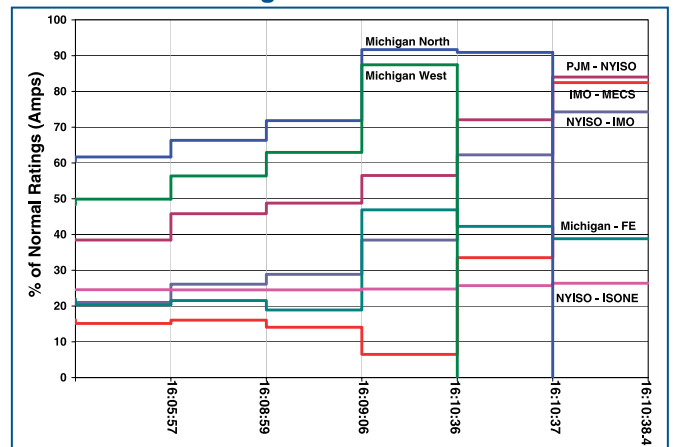
Figure 6.14. Simulated Regional Interface Loadings from 16:05:57 through 16:10:38.4 EDT

The Regional Interface Loadings graph (Figure 6.14) shows that loadings at the interfaces between PJM-NY, NY-Ontario and NY-New England were well within normal ratings before the east-west Michigan separation.

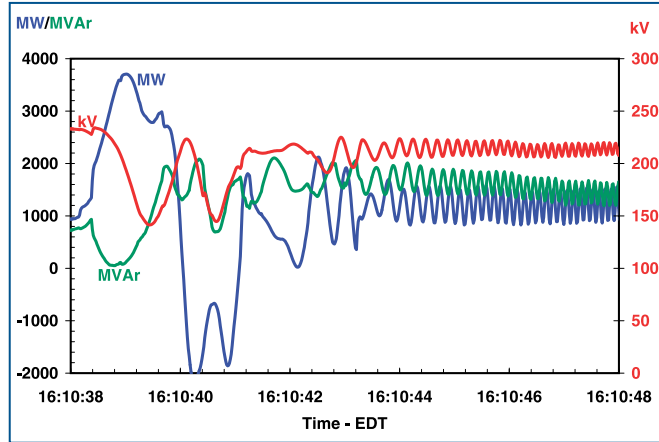
Figure 6.16. Active and Reactive Power and Voltage from Ontario into Detroit

This was a power surge of large magnitude, so frequency was not the same across the Eastern Interconnection. As Figure 6.16 shows, the power swing resulted in a rapid rate of voltage decay. Flows into Detroit exceeded 3,700 MW and 1,500 MVAR—the power surge was draining real power out of the northeast, causing voltages in Ontario and New York to drop. At the same time, local voltages in the Detroit area were plummeting because Detroit had already lost 500 MW of local generation. Detroit would soon lose synchronism

and black out (as evidenced by the rapid power oscillations decaying after 16:10:43 EDT).

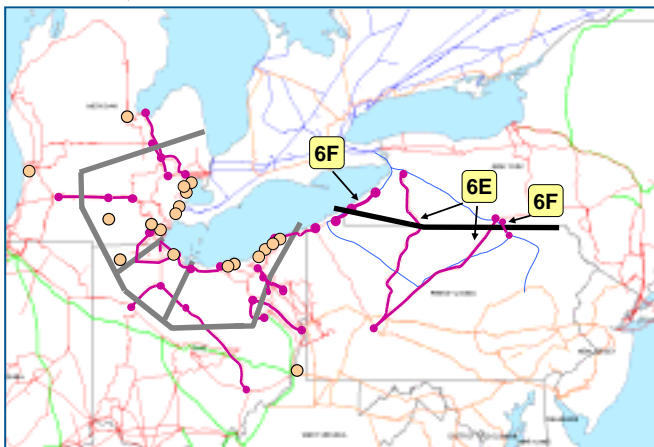
Figure 6.20. Western Pennsylvania Separates from New York, 16:10:39 EDT to 16:10:44 EDT

Responding to the swing of power out of Michigan toward Ontario and into New York and PJM, zone 1 relays on the 345-kV lines separated Pennsylvania from New York (Figure 6.20). Homer City-Watercure (177 miles or 285 km) and Homer City-Stolle Road (207 miles or 333 km) are very long lines and so have high impedance. Zone 1 relays do not have timers, and operate instantly when a power swing enters the relay target circle. For normal length lines, zone 1 relays have small target circles because the relay is measuring a less than the full length of the line—but for a long line the large line impedance enlarges the relay’s target circle and makes it more likely to be hit by the power swing. The Homer City-Watercure and Homer City-Stolle Road lines do not have zone 3 relays.

Given the length and impedance of these lines, it was highly likely that they would trip and separate early in the face of such large power swings. Most of the other interfaces between regions are on short ties—for instance, the ties between New York and Ontario and Ontario to Michigan are only about 2 miles (3.2 km) long, so they are electrically very short and thus have much lower impedance and trip less easily than these long lines. A zone 1 relay target for a short line covers a

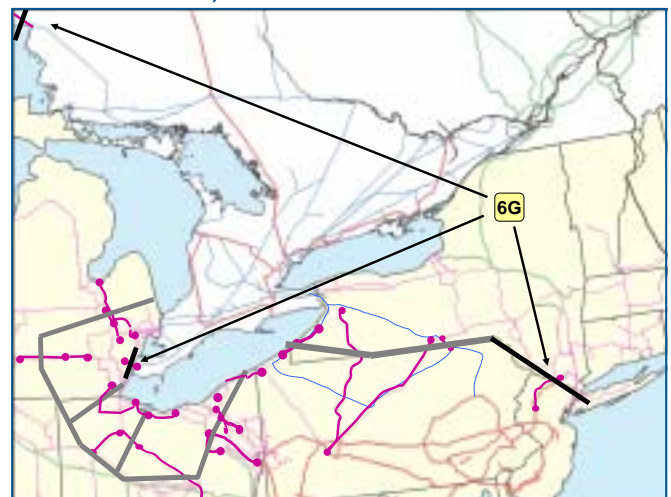
Figure 6.21. Northeast Separates from Eastern Interconnection, 16:10:45 EDT

At 16:10:43 EDT, eastern Michigan was still connected to Ontario, but the Keith-Waterman 230-kV line that forms part of that interface disconnected due to apparent impedance (Figure 6.21). This put more power onto the remaining interface between Ontario and Michigan, but

triggered sustained oscillations in both power flow and frequency along the remaining 230-kV line.

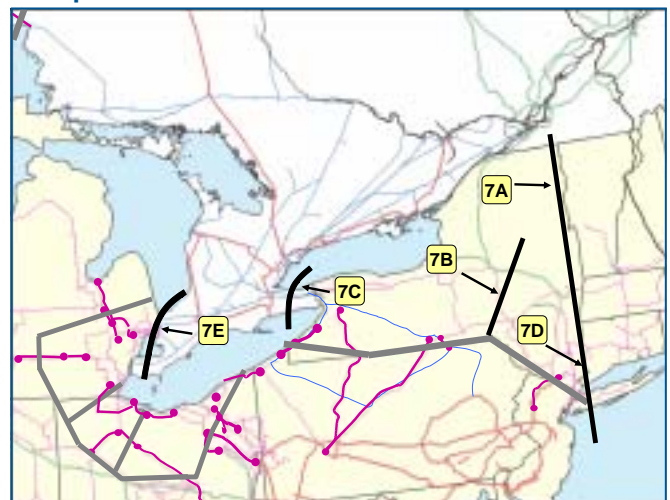
Figure 6.23. New York and New England Separate, Multiple Islands Form

During the next 3 seconds, the islanded northern section of the Eastern Interconnection broke apart internally. Figure 6.23 illustrates the events of this phase.

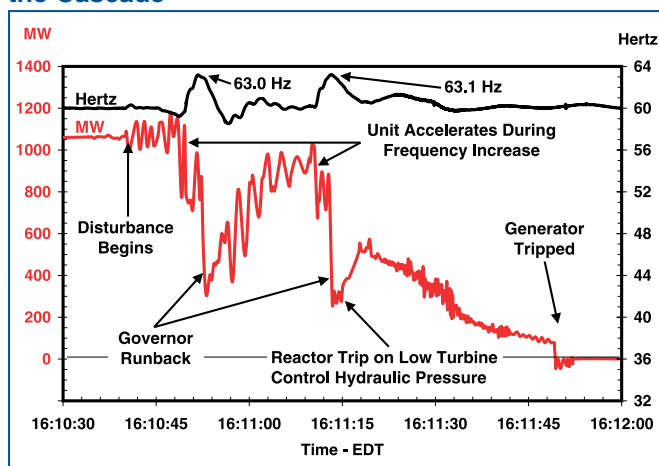
Figure 6.25. Events at One Large Generator During the Cascade

it back again as some frequencies changed several times by as much as 3 Hz (about 100 times normal deviations). Figure 6.25 is a plot of the MW output and frequency for one large unit that nearly survived the disruption but tripped when in-plant hydraulic control pressure limits were eventually violated. After the plant control system called for shutdown, the turbine control valves closed and the generator electrical output ramped down to a preset value before the field excitation tripped and the generator breakers opened to disconnect the unit from the system. This also illustrates the time lag between system events and the generator reaction—this generator was first disturbed by system conditions at 16:10:37, but did not trip until 16:11:47, over a minute later.
